The lost digit - Buk 3x2

A bellngcat Investigation

Introduction

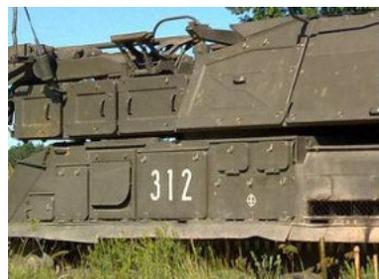
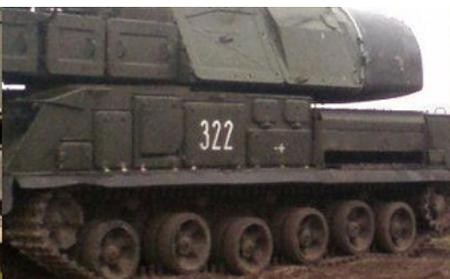
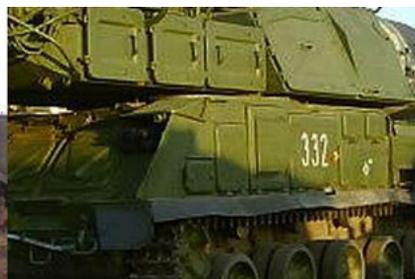
Buk 312 - detail

Buk 322 - detail

Buk 332 - detail

Below are the three comparisons for each of the three Buks. It can be seen that each Buk has its own distinctive features and side skirt profile. The direct comparison reveals that none of the three Buks can be conclusively identified as 3x2 by only using this methodology. For each Buk, there are visible differences in the visible "wave form."

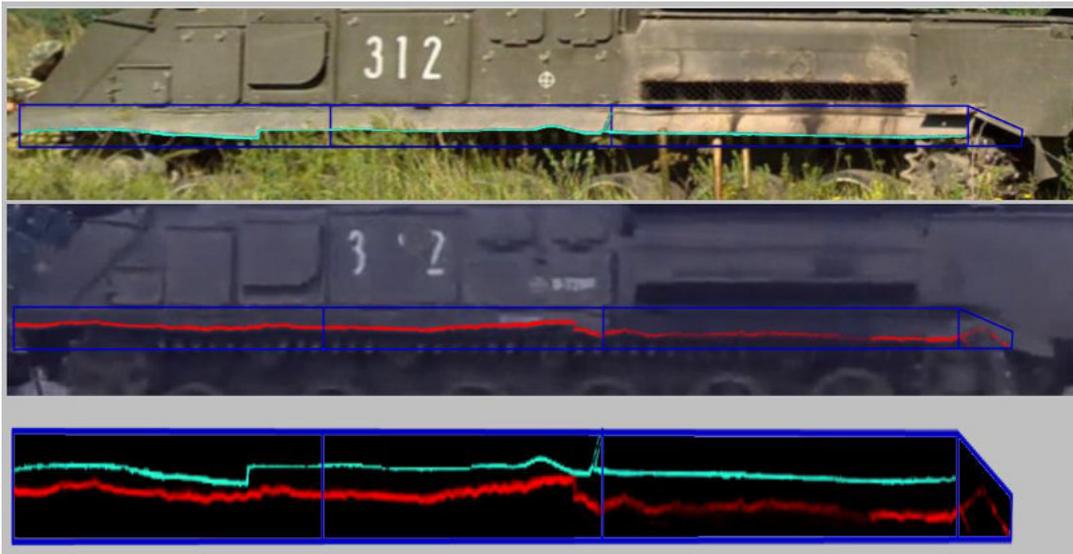
"Fingerprint" comparison between Buk 312 and Buk 3x2

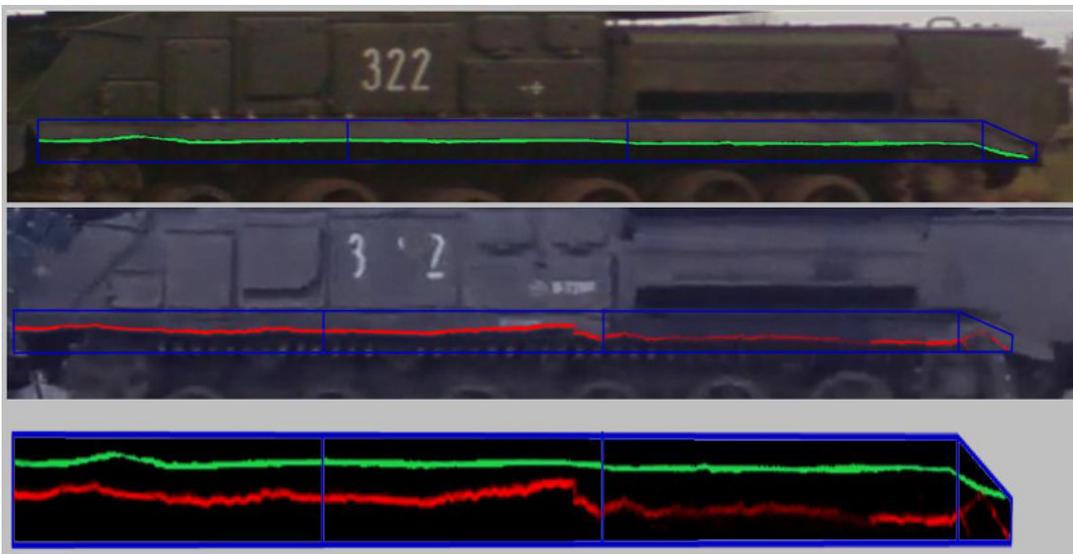
"Fingerprint" comparison between Buk 322 and Buk 3x2

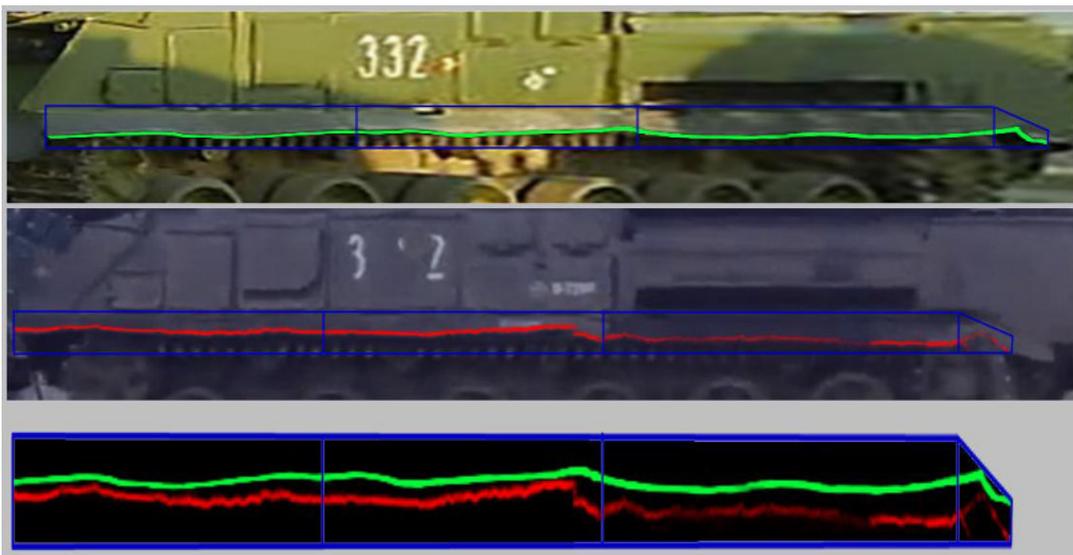
"Fingerprint" comparison between Buk 332 and Buk 3x2

In case of Buk 332 it is known that after 2010, the year the reference photo for the comparison was taken, its side skirt was severely damaged.¹⁹ The damaged parts were most likely replaced. Since no comparison photo is available for the "fingerprint" after these repairs, the non-result of the side skirt comparison is obviously inconclusive for this Buk. A similar clear reason that might have affected the side skirt is not documented by the available material for Buk 312 and 322. However, because of the inconclusive result of this comparison due to a lack of more current imagery, other features of Buk 3x2 are considered in the next subsection.

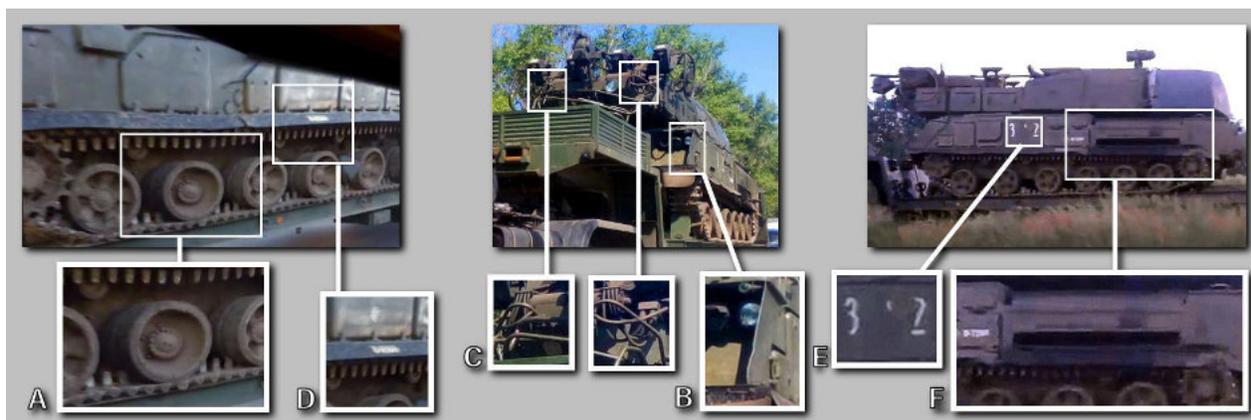
Individual features of Buk 3x2 – Details of video and photos^{20 21 22}

The Buk 3x2 that was part of the June convoy has at least six additional notable features that allow a more accurate comparison with the three Bucs (312, 322 and 332) from the 53rd Anti-Aircraft Missile Brigade. None of these features alone is conclusive enough to allow a clear identification. However, the combination of all these uncommon features together form a unique set of characteristics and can be considered suitable for a positive identification.

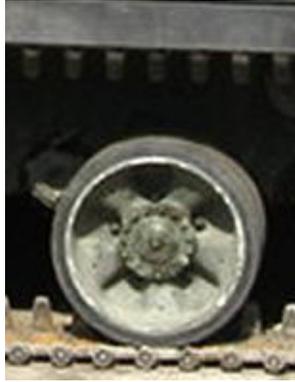
Spoke wheel

²⁵ For the purpose of this report, these two types of wheels will be called spoke and hollow wheels. The spoke wheel has five radial reinforcing ribs, and the hollow wheel is axially symmetrical without ribs.

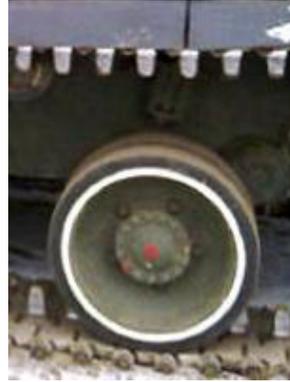
Hollow wheel

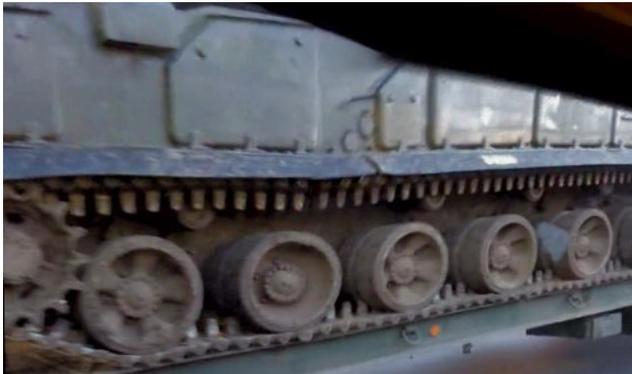
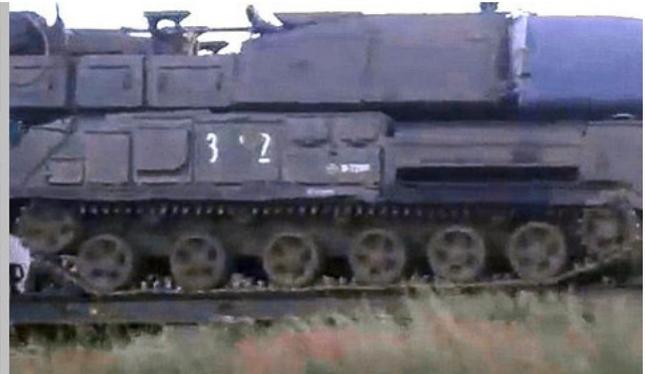
Buk 3x2 road wheels, right side²⁷

Buk 3x2 road wheels, left side²⁸

It is noticeable that Buk 3x2 has almost exclusively spoked wheels; however, at least one wheel is hollow.²⁹ This hollow wheel is located on the right at the second position from the left. It is not possible to identify the type of the last wheel on the right side.

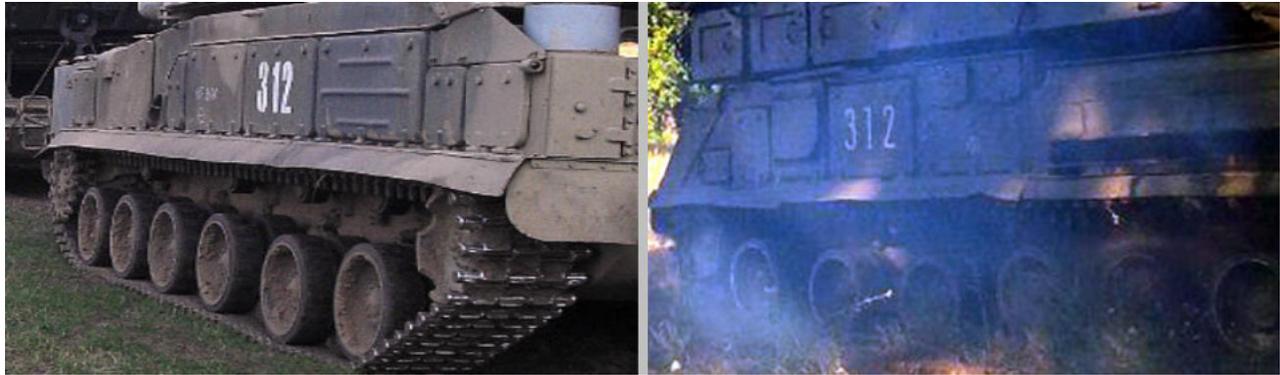
Buk 312 has exclusively hollow wheels. The exact arrangement and type of wheels for Buk 312 can be seen below:

Buk 312 road wheels, right side ³⁰

Buk 312 road wheels, left side ³¹

This comparison shows that Buk 312 can be excluded, since it has only hollow wheels. It seems implausible that 11 wheels were replaced before June 2014. Buk 322 has only spoke wheels and missed the hollow wheel on the right side. Buk 332, however, has the exact same visible wheel profile as 3x2: all spoked wheels, except for the second wheel on the right side being hollow.

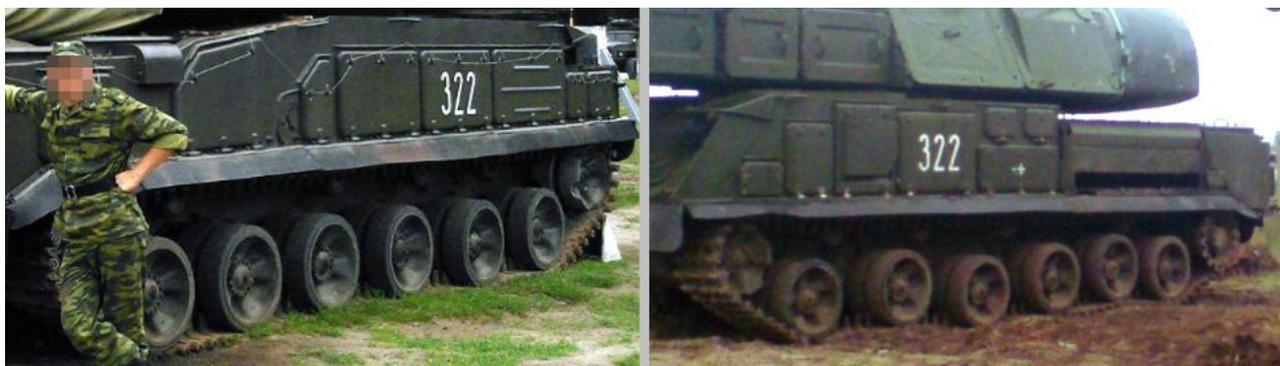
Buk 322 has exclusively spoked wheels. The arrangement and type of road wheels for Buk 322 can be seen below:

Buk 322 road wheels, right side ³²

Buk 322 road wheels, left side ³³

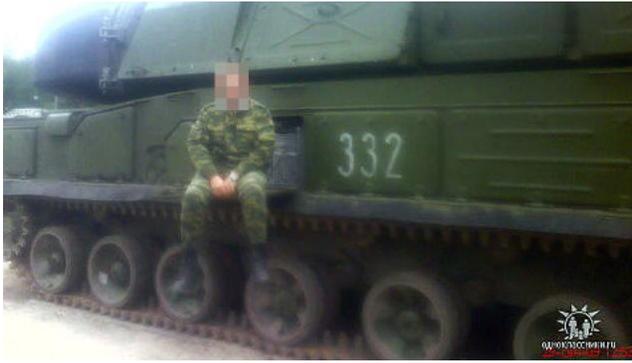
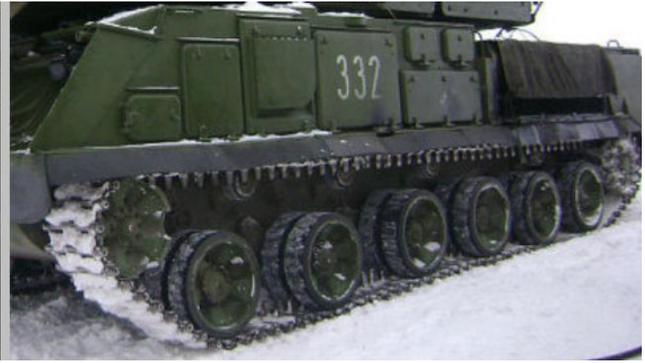
Buk 332 has exclusively spoked wheels except for a wheel on the right side. The roller on the second position on the right side is a hollow wheel. The arrangement and type of wheels for Buk 332 can be seen below:

Buk 332 road wheels, right side^{34 35}

Buk 332 road wheels, left side³⁶

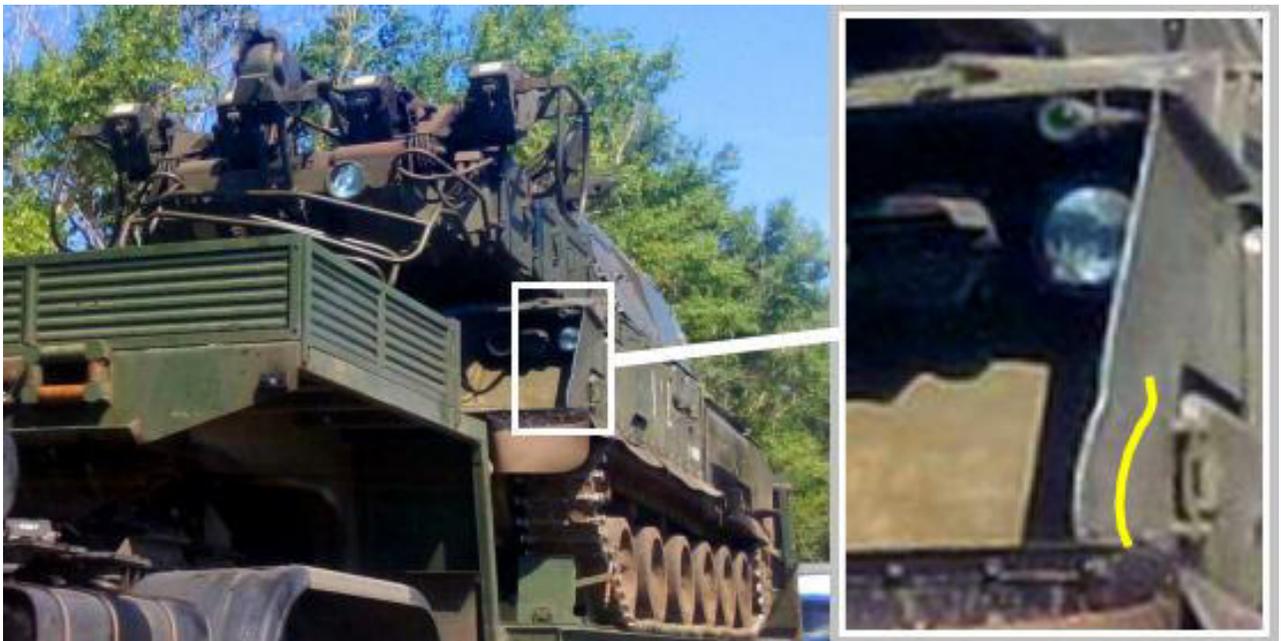
On a photo of Buk 3x2 taken near Alexeevka, Russia, an inverted S-shaped dent is visible on the left side panel. Below is an image from the June convoy and a highlighting of the damage. Only the lower part of the side panel is damaged with a quite specific shape, making this damage suitable for a comparison.

Buk 3x2 – Dent in the side panel³⁷

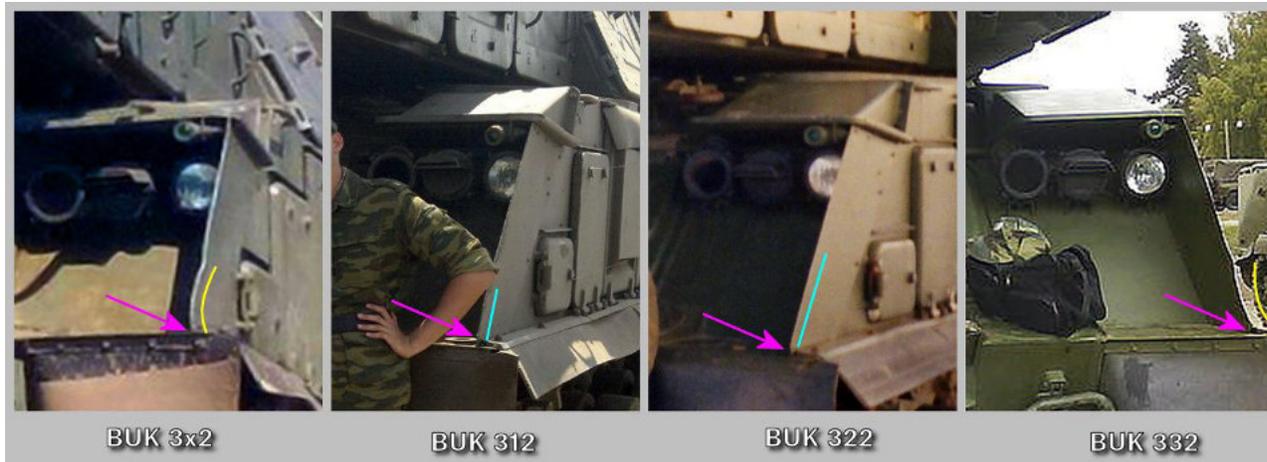
Compare - Dent in the side panel - Details of photos^{38 39 40 41}

The comparison clearly shows that only the side panel of Buk 332 shows the same type of damage. The damaged area of the side panel appears near identical compared to Buk 3x2.

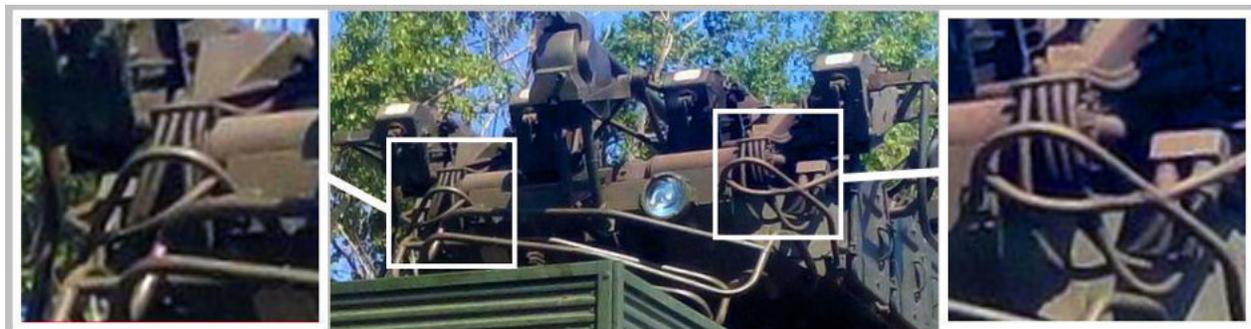
On the revolving turret of the Buk is a cable connection, where on each side there are four cables leading to the missile erector. In total, there are eight cables which can be compared.

Buk 3x2 - Cables connection to the missile erector - Details of photo⁴²

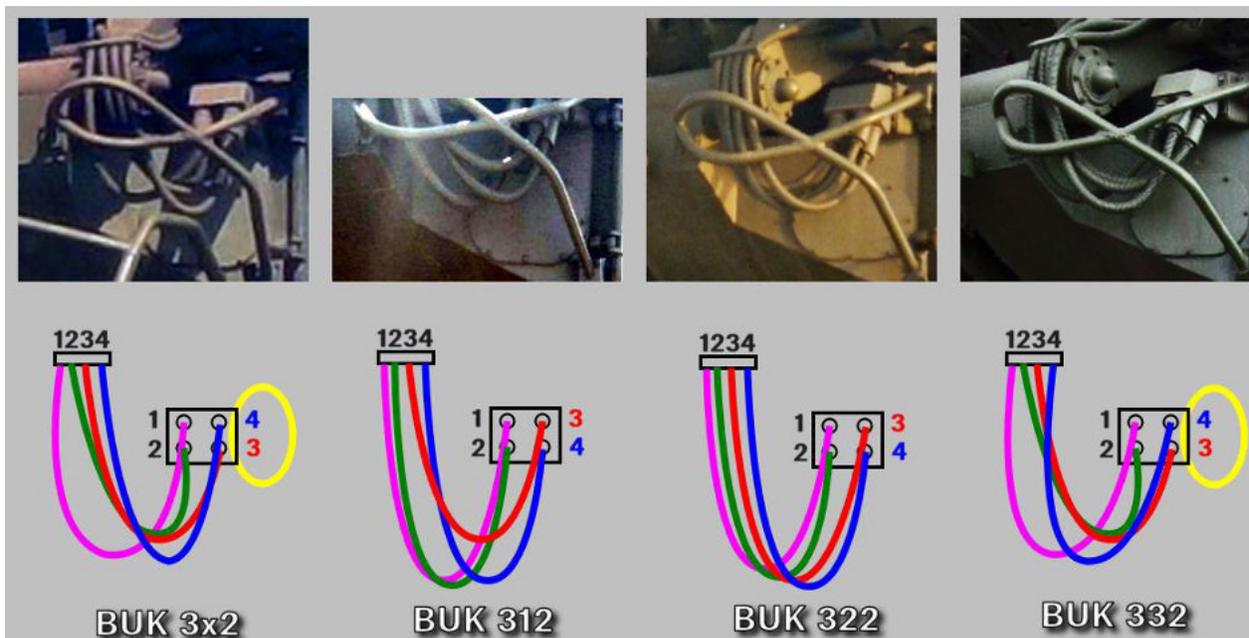
Buks 3x2, 312, 322 and 332 - cable connection on the right side - Details of photos ^{43 44 45 46}

Only Buk 332 has similarities with Buk 3x2's cables and connections. The blue-marked cable four is connected to the top plug on the turret chassis. Buk 312 and 322 show a different cabling, and cable four is connected to the bottom plug. Also, Buk 312, 322 and 332 show a distinct shape of the cabling, and only the shape of Buk 332 resembles that of the cabling of 3x2. The figure below shows the cables connection on the left side:

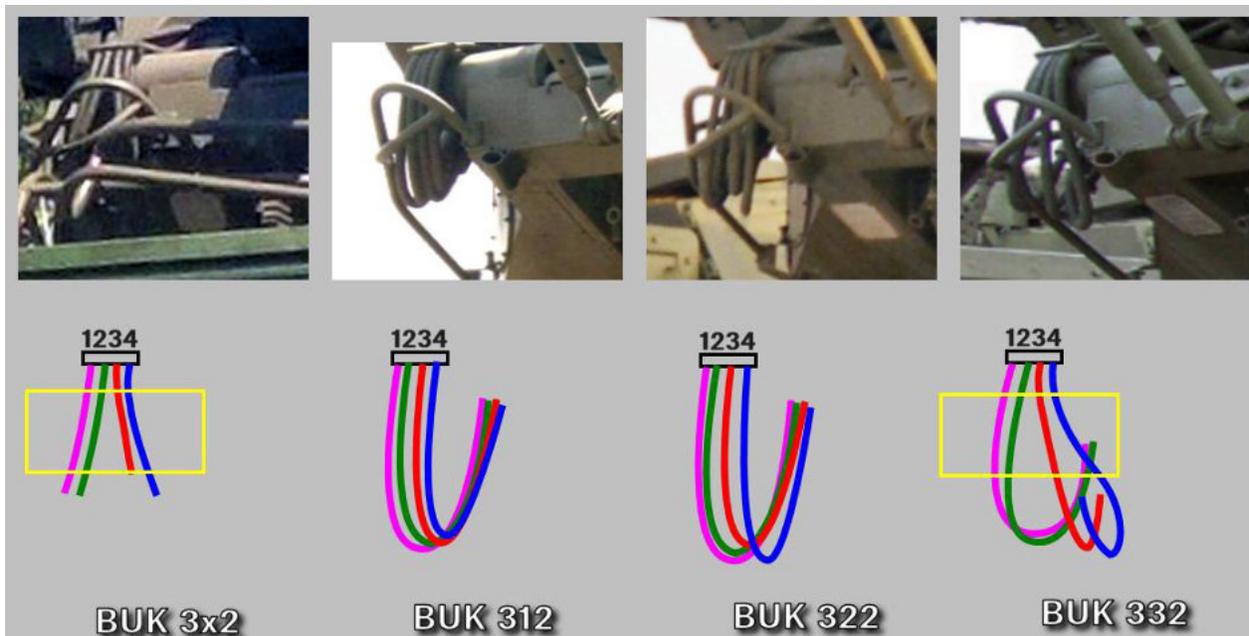
Buks 3x2, 312, 322 and 332 - cable connection on the left side - Details of photos ^{47 48 49}

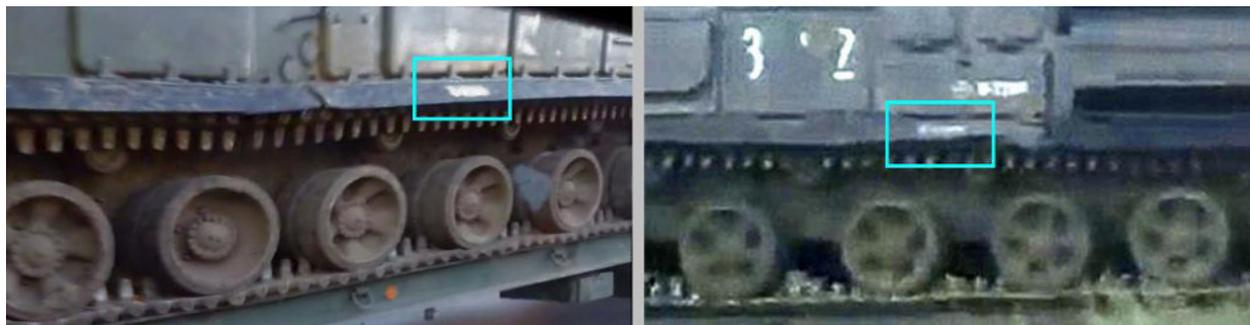
In the imagery available for Buk 3x2, white marks are visible on both side skirts directly below the center of gravity mark. Presumably, the white mark is the inscription "H-2200", a railroad transport code for dimensions of oversized cargo. Only Buk 3x2 had such a mark on the side skirts in the June convoy. Thus, in this convoy, the white mark on both side skirts is a unique feature of Buk 3x2.

Buk 3x2 - White marks on both sides of Buk - Details of videos^{50 51}

The reviewed photos of 53rd Anti-Aircraft Missile Brigade do not show this label on this position on Buk 312, 322 or 332. However, considering that this mark is added specifically before railway transport, the mark was likely added after the last available reference photo. Available photographs document that this position for the "H-2200" mark on the side skirt is used by the 53rd Anti-Aircraft Missile Brigade.

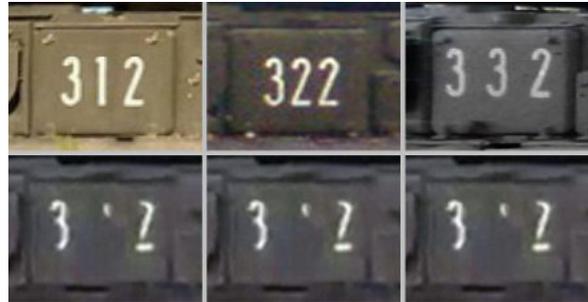
the three Buks shows that the font is the same for all four; however, only Buk 332 shows the same spacing and alignment of the 3x2. Even more, the two visible digits are a perfect match.

Comparison of the font and the spacing between the digits – Details of photos ^{52 53 54}

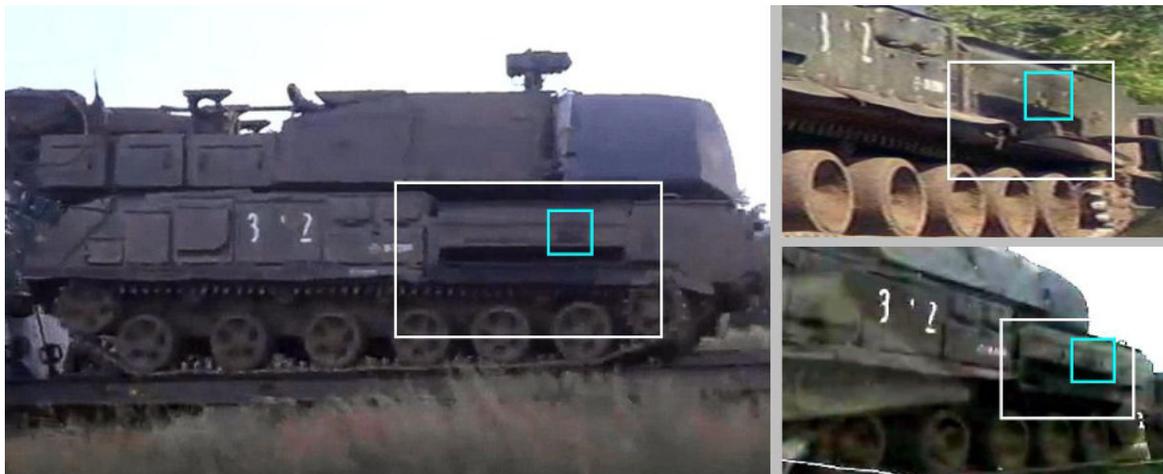
On all photos of the left side of Buk 3x2, strong dark patches can be seen on the side skirts below the exhaust. These patches are most likely caused by oil. Additionally, a striking soot or oil stain is located above the exhaust. Oil stains and soot deposits are certainly only a temporary feature because they can disappear by cleaning or repainting. However, a distinctive shape and position could also be caused by a special feature of the engine or the exhaust system, and a similar form at the same spot likely recurs, acting as indirect evidence of a persistent feature.

Buk 3x2 – Soot deposits or oil stains - Details of video and photos ^{55 56 57}

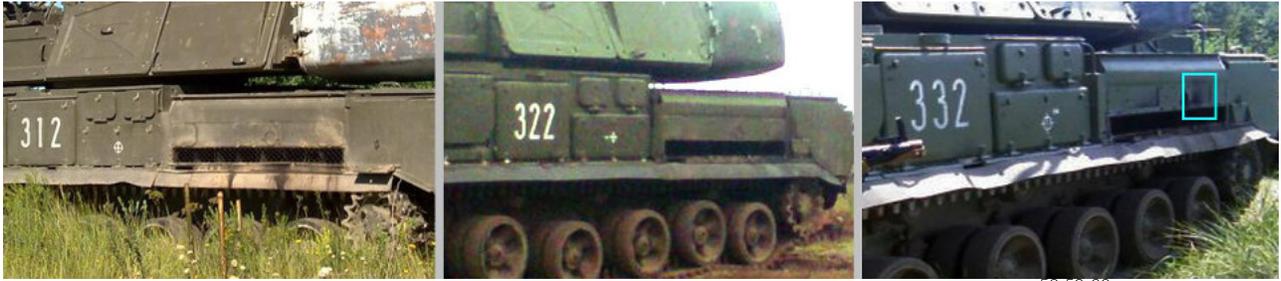
Soot deposits or oil stains at Buk 312, Buk 322 and Buk 332 – Details of photos ^{58 59 60}

The oil stains on the side skirts are not recognizable in the photos of the three Bucs. However, some photos of Buk 332 show a soot deposit above the exhaust, approximately at the same position as that of of Buk 3x2.

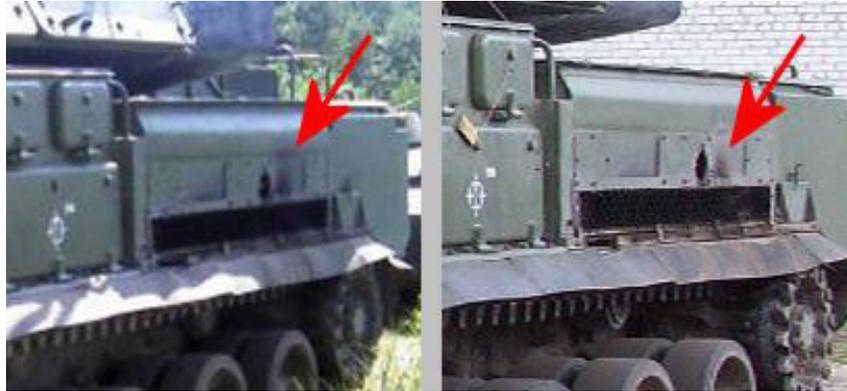
Buk 332 – Soot above the exhaust on Buk 332– details of photos ^{61 62}

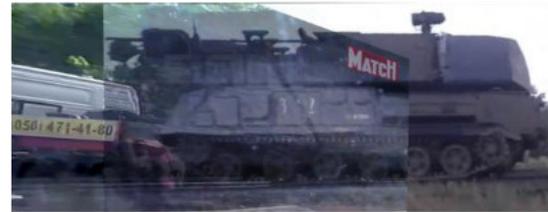
Buk Side skirt "fingerprints"

The comparison of the side skirts showed a strong match, however, there is one area with a notable change in "wave form". It was found that this can be explained by an observable deformation of the side skirt.⁶⁵

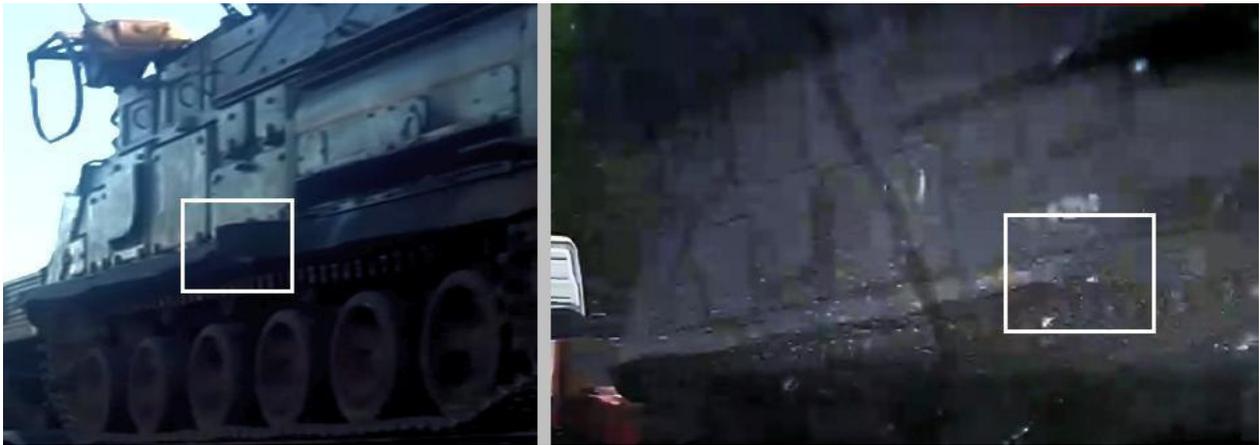
The damaged and torn side skirt close to the exhaust on the left side of the Buk can be seen in the photos from Paris Match showing the Buk on the trailer on 17 July in Donetsk. In the same area above the fourth wheel, a similar damage pattern can be seen on Buk 3x2 in a video made in Russia.

Damage to the side skirt - Details of Video⁶⁶ and photo⁶⁷

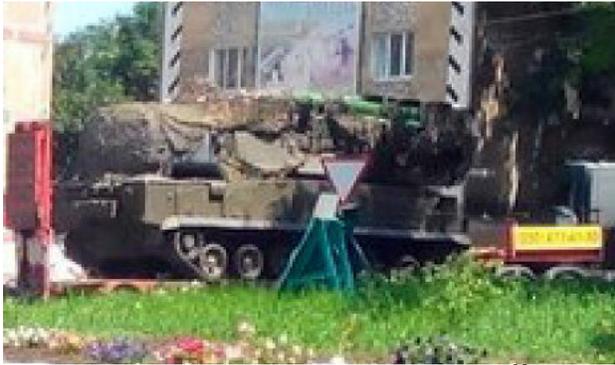
Photo of a user from VKontakte - Torez⁶⁸

Neither image gives a clear view of the wheels. However, it is possible to state that at least some - and most likely all six - wheels are spoked on the left side. The low-resolution photo of the right side does not show all wheels. It is only possible to clearly identify the first road wheel as being from type spoke wheel. For the second wheel, no spokes are visible in the original resolution, which indicates a hollow wheel. However, the resolution is too low to reach a definite conclusion. It is not possible to identify the type of the other wheels. The third wheel is located in the shadow, and the other wheels cannot be assessed because they are hidden by other objects.

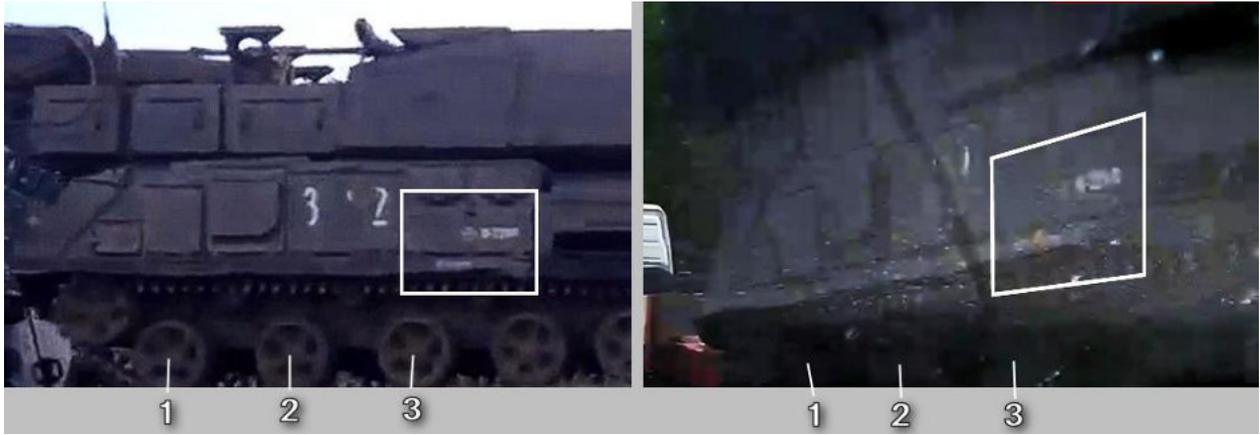
White mark left side - right above the third wheel from the left- Details of Video ⁷¹ and photo ⁷². See the numbered wheels (1, 2, 3) for reference of the mark's location in the space between the 3rd and 4th wheels.

The white marks on the Buk in the separatist-controlled area are in the exact same position as the white marks of Buk 3x2 in the Russian convoy in June 2014. The position of these transport markings is usually close to the sign marking the center of gravity. However, imagery of other Bucs with similar markings shows that these transport markings are not in the exact same locations.

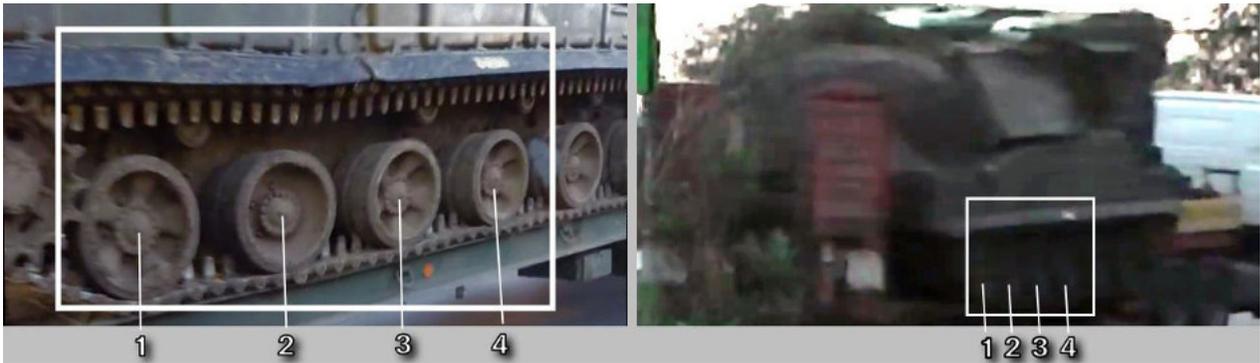
White mark right side- directly above the fourth wheel from the left - Details of videos ⁷³ ⁷⁴

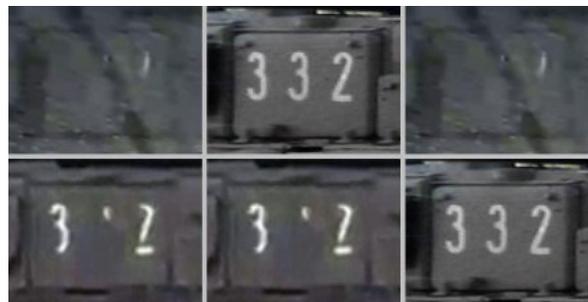
Comparison of digits or fragments of digits for Buk xxx, Buk 3x2 and 332

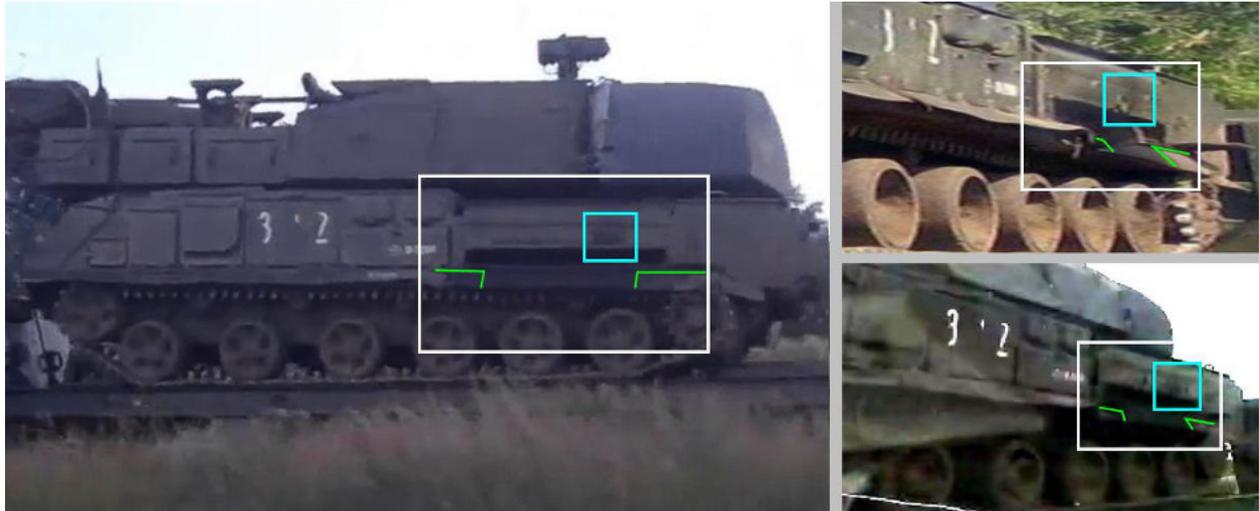
Another feature of Buk 3x2 are the oil stains and soot deposits above and below the exhaust.

Soot deposits / oil stains on Buk 3x2 - Details of videos^{75 76} and photo⁷⁷

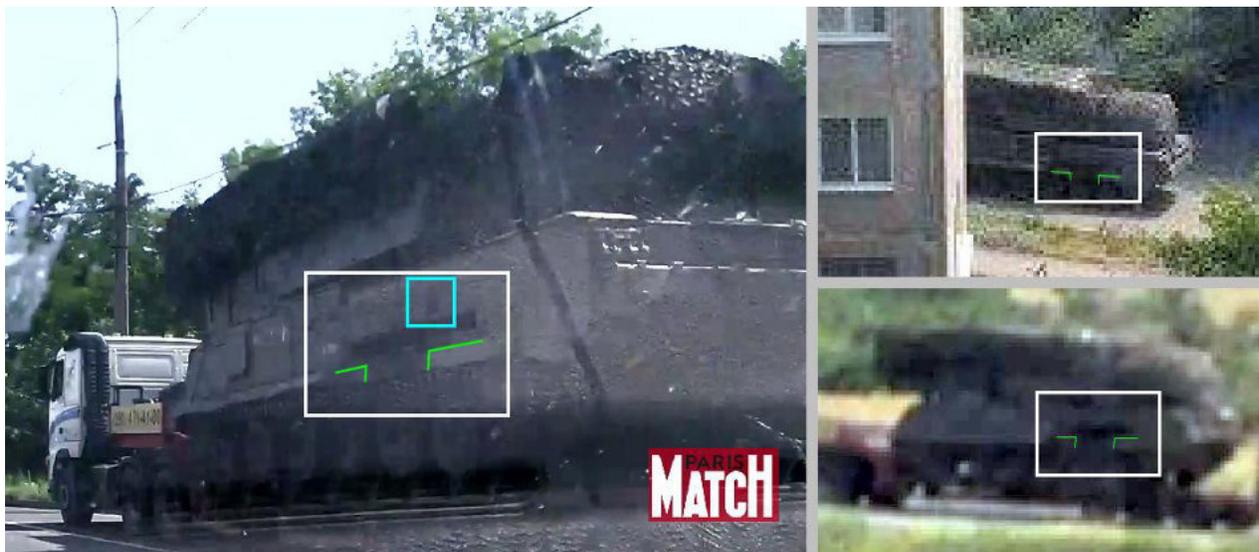
This characteristic oil stains or soot deposits are also found in two pictures and a video of Buk in separatist-controlled areas of eastern Ukraine.

Buk on 17 July 2014 in the separatist territory - soot deposits / oil stains - Photos^{78 79} and video⁸⁰
